**Landscape Maintenance Manual
Excerpted from
Preservation Management Plan
for the
Elm Street Cemetery
Braintree, Massachusetts
Volume I: Report**

**The Town of Braintree
Braintree, Massachusetts**

February, 2011

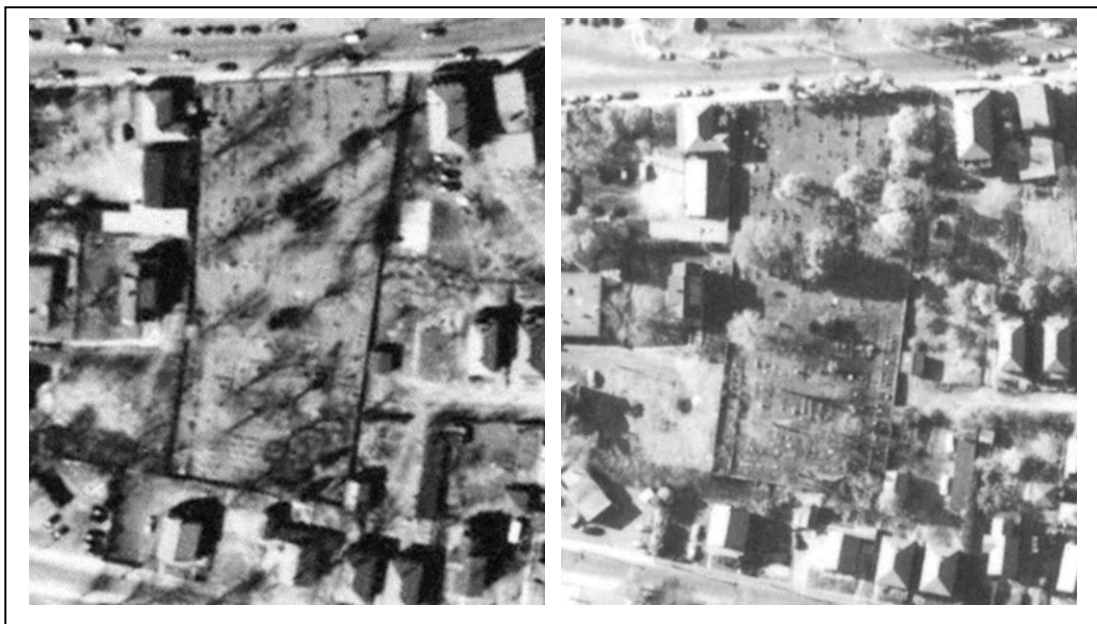
Considering the years of neglect, it is likely that by the early 1990s many of the original plantings had succumbed. It is also likely that some of the plantings, such as the Japanese maple, were rather recent introductions into the cemetery landscape (based on their size). Although some reduction in landscape plantings is recognizable on historic aerial photographs for the 1940s and 1950s, it is clear that the greatest loss occurred during the late 1990s (Figure 3-27).

Figure 3-27. Aerial photographs of the cemetery in the mid-twentieth century. On the left is an April 1947 photograph. On the right is a photograph from May 1954.

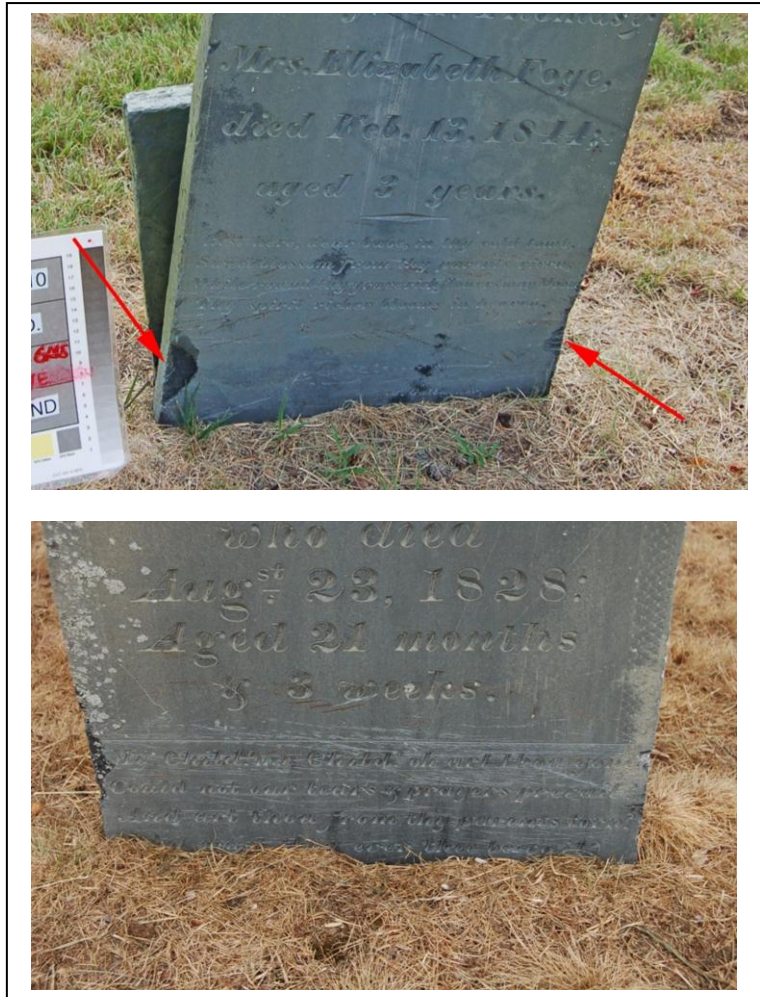
Stones in the cemetery clearly reveal the damage that can be done by large equipment and less than perfect handling (Figure 3-28).

In addition to mowing, nylon trimmers are used around monuments, coping, fencing, and plantings. This is an acceptable practice, but it is critical that a very light weight line be used – along with worker attention – to minimize damage to soft stone such as marble. The maximum line diameter for use in the cemetery should be 0.065”. Thicker lines will cause unnecessary damage to the stones. Unfortunately the town is using trimmer line that is 0.095” and Figure 3-28 reveals damage done to markers by the use of this line.

Figure 3-28. Examples of mower and trimmer damage. Top photo shows mower impacts on the sides of a slate stone. The bottom photo shows parallel scars from too heavy nylon trimmer line.

We recommend that the use of riding mowers be abandoned at the Elm Street Cemetery and only walk behind mowers with decks no larger than 21-inches be used. Even with the smaller sized mowers, all equipment used in the cemetery should have a closed cell foam pad attached to the sides and front edges. This bumper will help to minimize accidental damage.

The use of large deck mowers in the cemetery is causing damage to monuments and the practice must be stopped. Only 21-inch walk-behind mowers should be used on the cemetery grounds. All mowers should be fitted with closed cell foam bumpers to reduce accidental damage to the stones. These bumpers should be inspected on a weekly basis and replaced as needed.

The nylon trimmer line being used by the town currently is too heavy and is resulting in damage to monuments. The existing 0.095" line must be replaced by line that is not over 0.065".

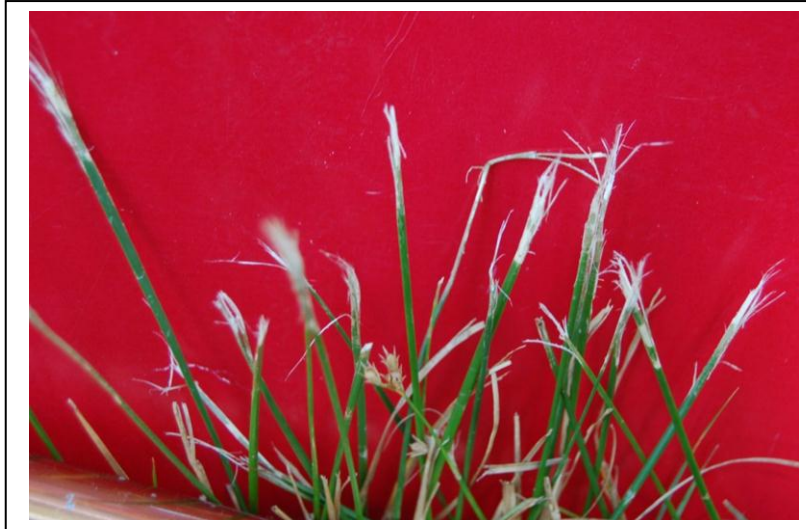
It is also critical that mower blades be frequently sharpened. Dull mowers tear the grass blades rather than cut them (Figure 3-29). This can result in excessive injury to the plants as well as a brownish cast to the turf. In addition, mower blade injury can cause several adverse effects, including increased turfgrass water use and the promotion of disease infection.

Figure 3-29. Grass at the Elm Street Cemetery has been cut with very dull mower blades, resulting in the leaves being torn, rather than cleanly cut.

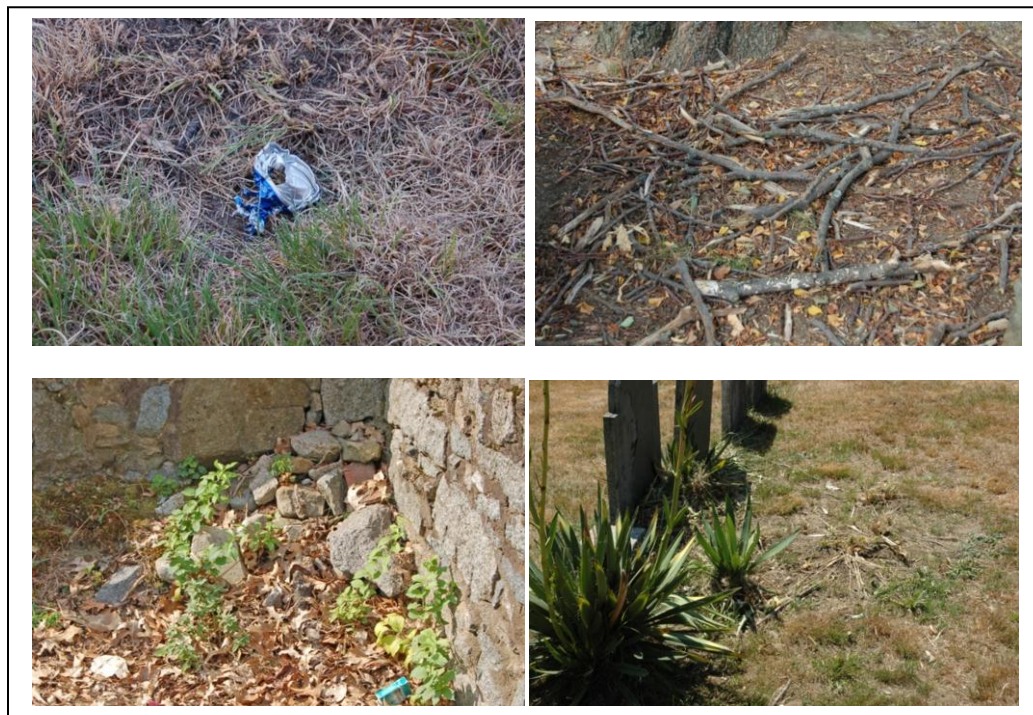
A final issue of concern is that the Roads and Grounds staff are not picking up trash in the cemetery prior to mowing. Instead, the trash is being mowed over. We observed plastic, aluminum, and other items (including remnant plot chains) that had been mowed over (Figure 3-30). The cemetery, at the time of the assessment, also exhibited multiple areas where leaves and other trash had been allowed to collect – all of this debris must also be removed prior to mowing.

simply mowed over, rather than being mowed around. This indicates a disregard for the historic landscape and is inexcusable. Sufficient care must be taken to ensure that all plantings are adequately protected from mowing or other maintenance activities.

In other areas we observed that the mowing had severely damaged plantings. For example, Figure 3-30 illustrates yuccas that were

Figure 3-30. Unacceptable mowing practices include a failure to collect trash, litter, and branches prior to mowing and mowing over plantings.

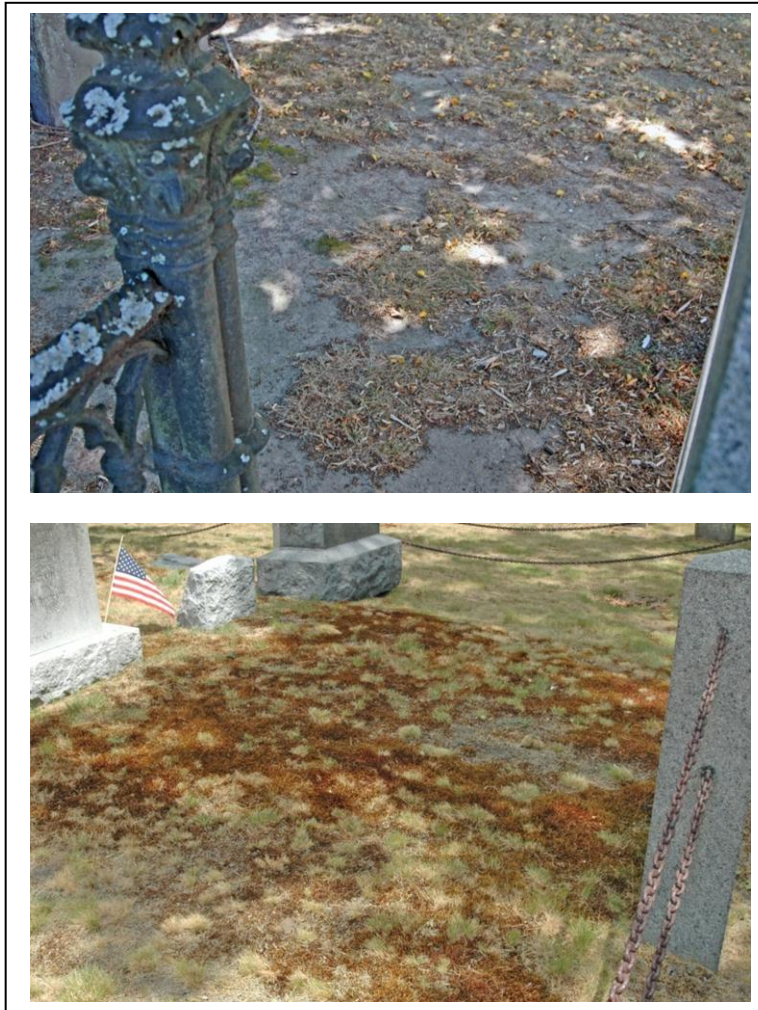
Figure 3-31. Lawn problems. The top photograph shows heavy soil compaction. The bottom photograph shows moss invading the turfgrass.

The assessment found a variety of weeds invading the turfgrass (Figure 3-31). While directly attacking these weeds using pre- and post-emergent herbicides may be necessary, other cultural practices should be instituted first. The most important is aeration. During this assessment we found that the cemetery soils were heavily compacted.

Compaction causes a variety of problems, including reducing drainage and inhibiting air exchange, decreasing soil oxygen, altering infiltration and percolation rates, and contributing to the build-up of thatch since the conditions for microbial activity and decomposition are adversely affected.

We also observed areas of dense moss growth. The presence of moss is often an indicator of compaction, improper soil pH, or too much shade. Since shade does not seem to be a major problem where the moss is

We recommend hollow tine core aeration with treatments at least twice a year, typically in May and September. Given the compaction level it may be necessary to core aerate the Elm Street Cemetery for several years before establishing a yearly schedule.

We recommend that the weed issue be revisited after core aeration and after appropriate fertilization for several years.

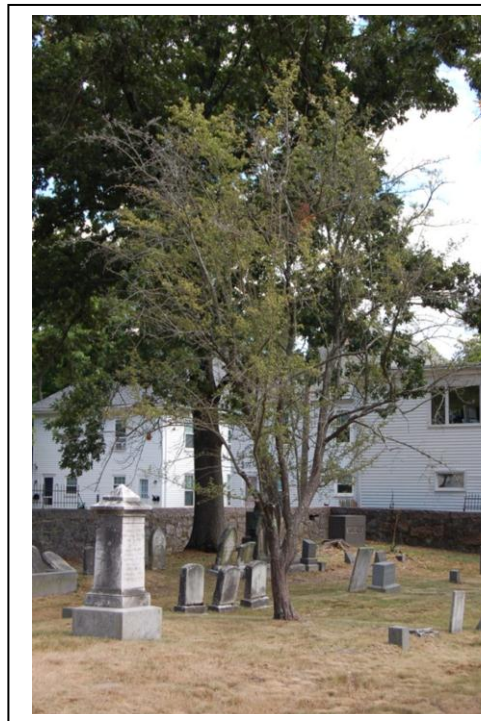
During the assessment our observations suggest that the remnant trees are generally healthy, although several require pruning to remove deadwood (especially the English hawthorn, Figure 3-32). Several additional trees could benefit from pruning to either thin or clean. Thinning is a technique of pruning that removes selected branches to increase light and air movement through the crown. This also decreases weight on heavy branches. The natural shape of the tree is retained and its overall health is improved. In cleaning, the pruning removes branches that are dead, dying, diseased, crowded, broken, or otherwise defective. This includes narrow crotches.

Figure 3-32. English hawthorn that requires pruning to remove dead wood.

Trees should be pruned in such a manner as to preserve the natural character of the plant and in accordance with ANSI A300 (Part 1) - 2001 standards.

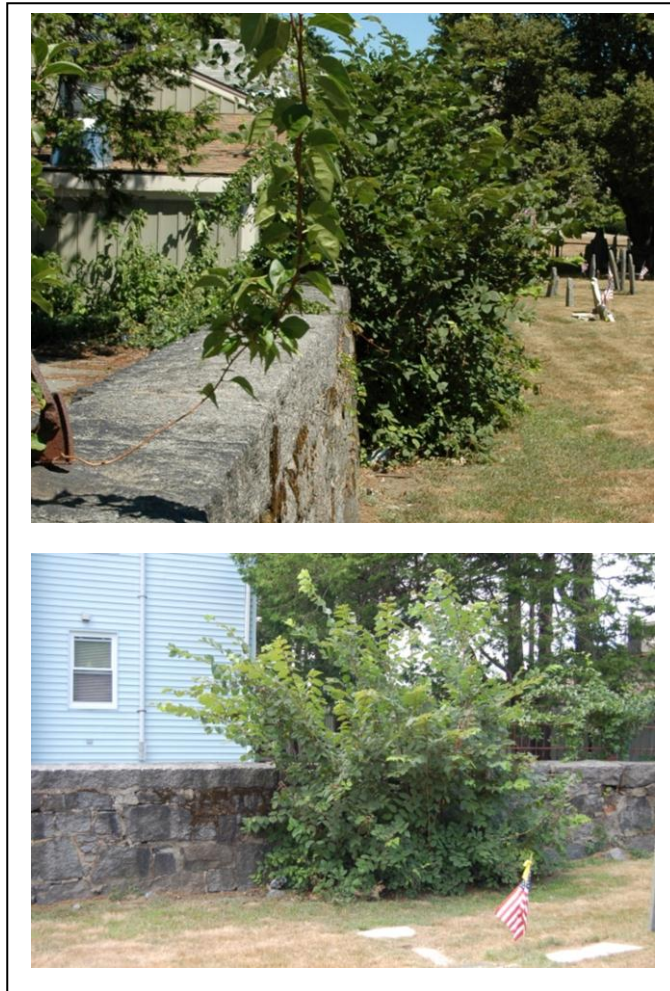
There are some situations in the cemetery where voluntary plantings have grown to interfere with the stone fence (Figure 3-33). These detract from the landscape and will ultimately pose problems for the maintenance of the fence. Those voluntary or weedy species on the cemetery should be removed.

Figure 3-33. Voluntary trees that are detracting from the cemetery landscape and that may cause eventual damage to the cemetery wall. These trees and weedy plants should be removed.

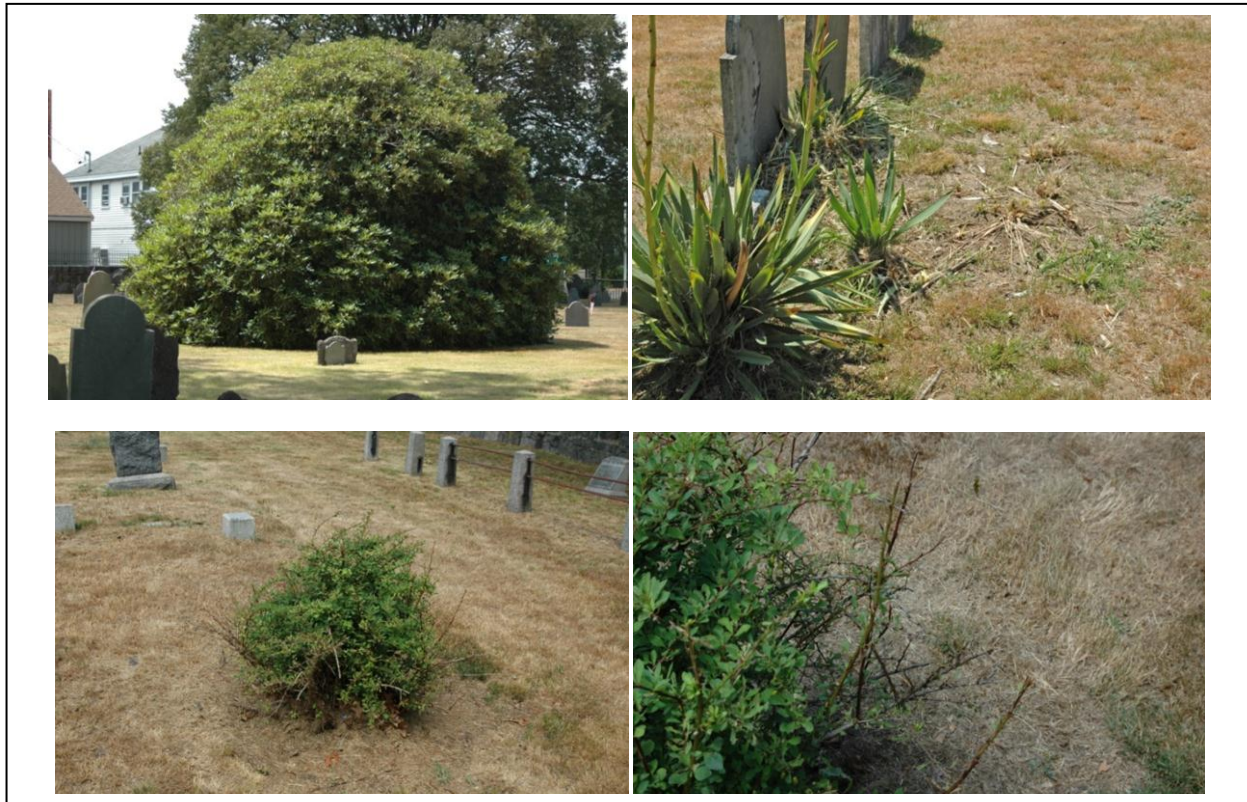
numerous yucca plants (many of which are being routinely mowed over) (Figure 3-35). Also present is a bed of day lilies (*Hemerocallis* spp.) in the southwest corner of the cemetery. They, too, are inexplicably being mowed over.

Figure 3-35. Shrubs at the Elm Street Cemetery. Upper left is the Rosebay Rhododendron, an excellent specimen that should be carefully tended. Upper right is an example of the yucca present in the cemetery. Many of these are being mowed over – a practice that should be halted immediately. Lower row shows the barberry that is being improperly “pruned” using a nylon trimmer.

It is again in the category of pruning maintenance that we see problems. A good example of this problem can be seen in Figure 3-35, where a barberry has been “pruned” using a nylon trimmer. This practice is even worse than shearing since it leaves the stems broken, crushed, and damaged, promoting disease and creating a rounded shape that is inappropriate for the shrub. In addition, deadwood that should be pruned out has been left intact.

The continuous shearing of the shrubs has caused a thick outer shell of foliage which creates dense shade on the interior branches. This continuous shade will result in significant foliage drop, decreasing the health, value, and aesthetics of the plants.

Shrubs are best pruned, rather than sheared, to maintain a natural shape and to keep plants at a desired size so that they do not outgrow their landscape too quickly. With much deadwood on their interiors, significant rehabilitation may be necessary – as in the case of the barberry.

Thinning (cutting selected branches back to a side branch or main trunk) is usually preferred over heading back. Thinning encourages new growth within the interior portions of a shrub, reduces the size, and provides a fuller, more attractive plant.

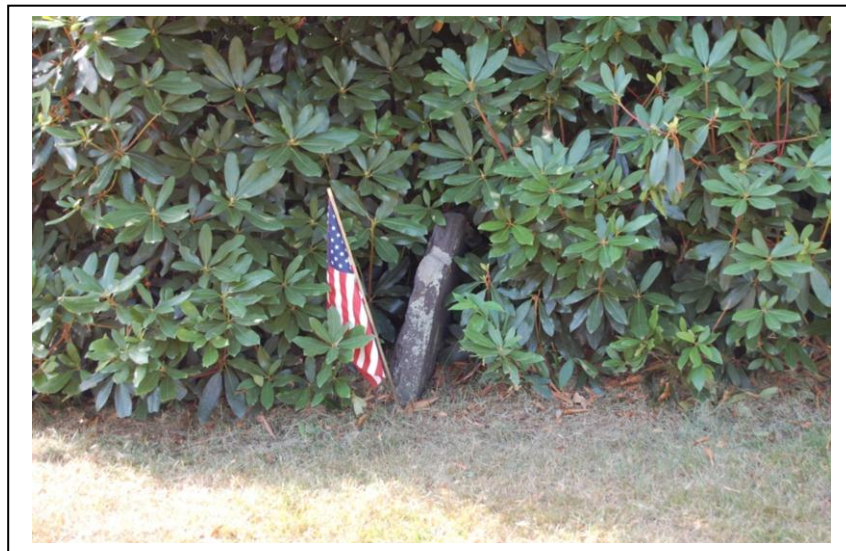
Figure 3-36. Stone at the edge of the rosebay rhododendron. Very judicious and careful pruning can help make the stone more visible without damaging this exceptional specimen.

The rhododendron has partially overgrown one stone (we carefully examined the interior of the plant and there are no other stones) (Figure 3-36). The plant may be pruned back moderately in this location in order to make the stone more legible. It is essential, however, that the pruning not become heavy-handed or damage this magnificent specimen.

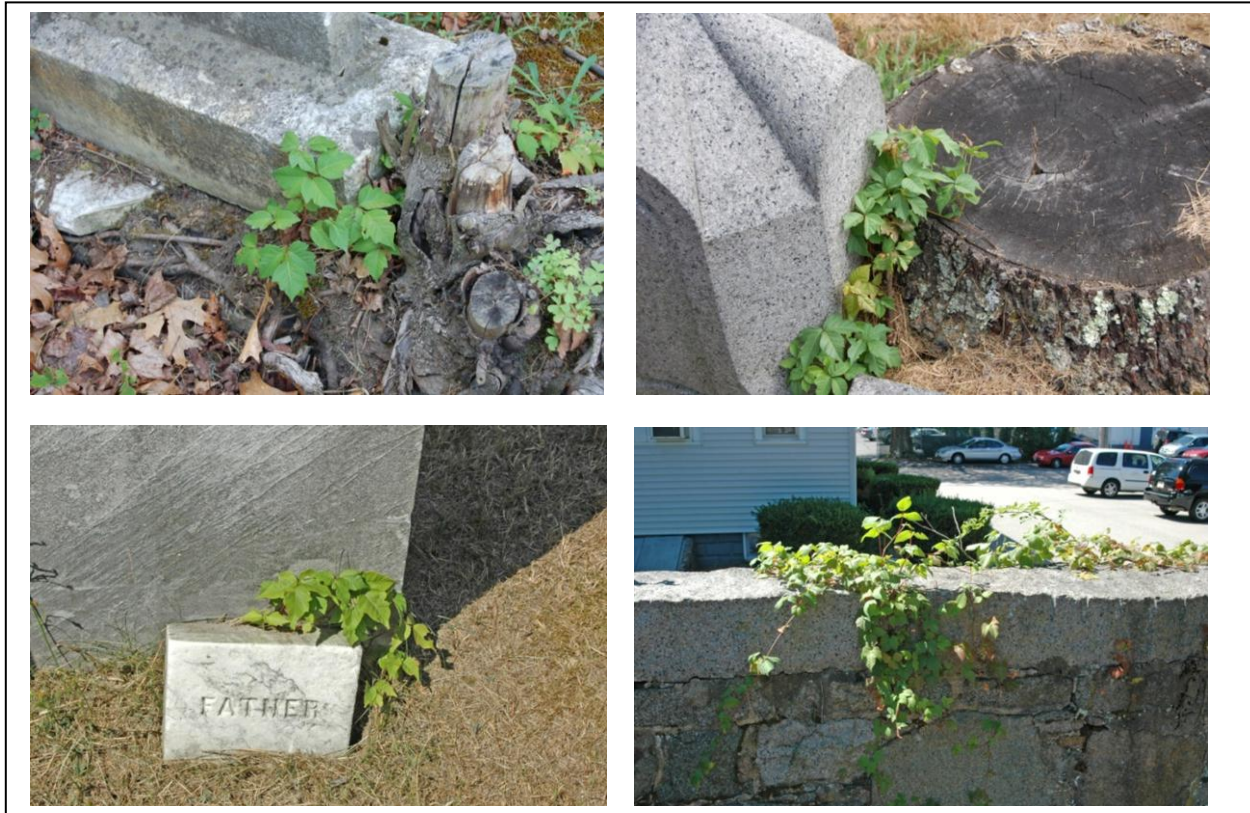
Poison ivy was found in numerous areas of the cemetery, including the southern and western walls, as well as around plots and stones (Figure 3-37).

Figure 3-37. Poison ivy is beginning to become established in the cemetery and should be manually

While not yet a significant problem, its presence in the cemetery is attributable to inadequate maintenance attention. It is found in areas where nylon trimmers cannot conveniently be used, indicating that the staff is not using clippers to remove the vine when observed.

Stone such as marble and granite can be damaged by the application of herbicides such as glyphosate, 2,4-D amine, and triclopyr typically used to treat poison ivy. Instead of spraying, we recommend that individual vines be cut and the freshly exposed stem be painted with herbicide to assist in the killing of the root system. A good herbicide is Dow's Garlon 4 (<http://www.cdms.net/ldat/ld0B0013.pdf>) which is 61.6% triclopyr (<http://npic.orst.edu/factsheets/triclogen.pdf>).
